# **Test Report**

Subject:	Corrosion test for LED Street light
Product:	LED Street light
Applicant:	EVERLITE LED LIGHTING CO., LIMITED
Applicant address:	Room 2015, Trend Centre, 29-31, Cheung Lee Street Chaiwan, HONG KONG
Supplier name:	NINGBO SKYZON ENERGY CO., LTD.
Supplier address:	NO. 19 KESAN ROAD, NINGHAI, 315600, NINGBO, PEOPLE'S REPUBLIC OF CHINA
Model Number:	EL-SL68(L)-200W; EL-SL18MA-20W;EL-SL18MA-30W;EL-SL18MA- 40W, EL-SL18MA-50W;EL-SL18MA-60W, EL-SL18MA-70W; EL-SL18MA-80W, EL-SL18MA-90W;EL-SL18LA-90W, EL-SL18LA- 100W;EL-SL18LA-120W, EL-SL18LA-150W;EL-SL18LA-160W
Requirement:	Test according to the following standard: ISO 9227 :2017 Corrosion tests in artificial atmospheres – Salt spray tests(Only test for Model EL-SL68(L)-200W)
Sample Receiving Date:	Dec 14,2018
Testing Period:	Dec 14,2018 to Jan 04,2019
Conclusion:	Pass

# 1. With reference to ISO 9227:2017 Corrosion tests in artificial atmospheres - Salt spray tests, the submitted sample was subjected to the following test

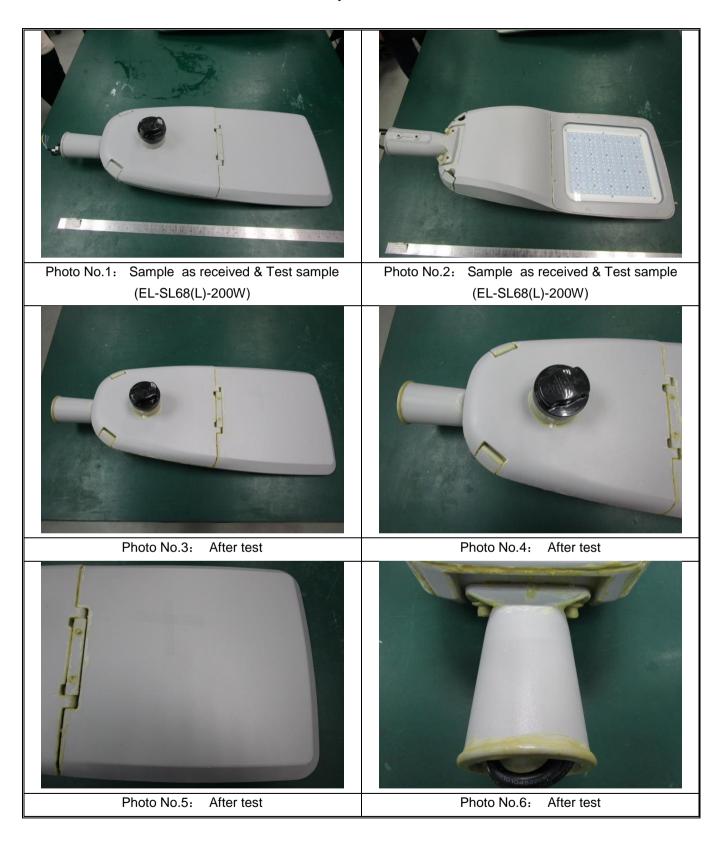
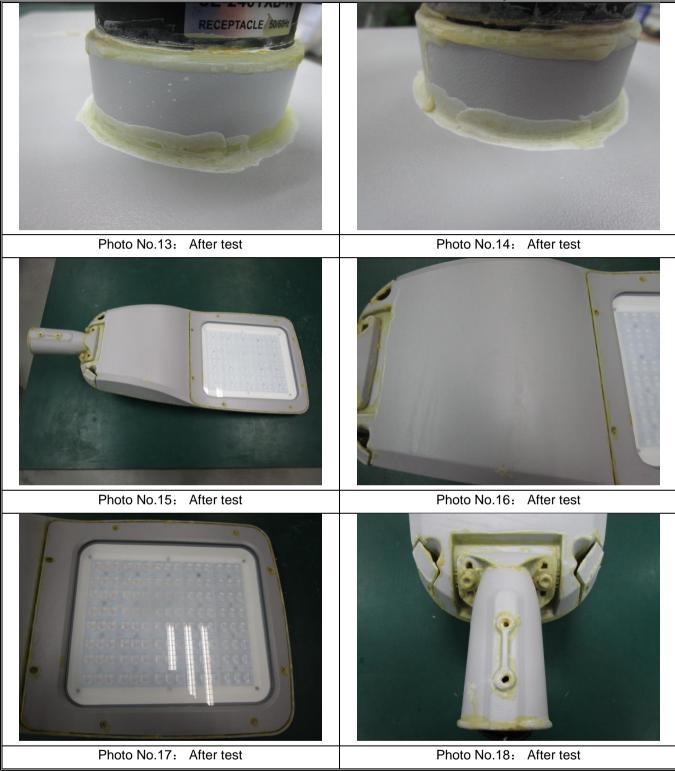
### **Sample Photos**

Test Result: No blistering was found on the sample after 2500 hours. No crack was found on the sample after 2500 hours.
